**DEPARTMENT OF TRANSPORTATION**

Contract #: 04-0120F4Cty: SF/ALA Rte: 80 PM: 13.2/13.9File #: 69.28**WELDING INSPECTION REPORT****Resident Engineer:**Pursell, Gary**Address:** 333 Burma Road**City:** Oakland, CA 94607**Report No:** WIR-004146**Date Inspected:** 21-Sep-2008**Project Name:** SAS Superstructure**OSM Arrival Time:** 700**Prime Contractor:** American Bridge/Fluor Enterprises, a JV**OSM Departure Time:** 1730**Contractor:** Zhenhua Port Machinery Company, Ltd (ZPMC), Changxing Island **Location:** Shanghai, China**CWI Name:** CK Chan / Jeff Chen**CWI Present:** Yes No**Inspected CWI report:** Yes No N/A**Rod Oven in Use:** Yes No N/A**Electrode to specification:** Yes No N/A**Weld Procedures Followed:** Yes No N/A**Qualified Welders:** Yes No N/A**Verified Joint Fit-up:** Yes No N/A**Approved Drawings:** Yes No N/A**Approved WPS:** Yes No N/A**Delayed / Cancelled:** Yes No N/A**Bridge No:** 34-0006**Component:** Tower**Summary of Items Observed:**

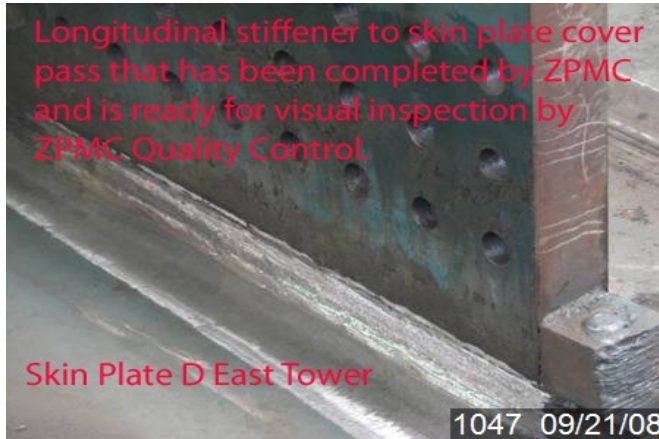
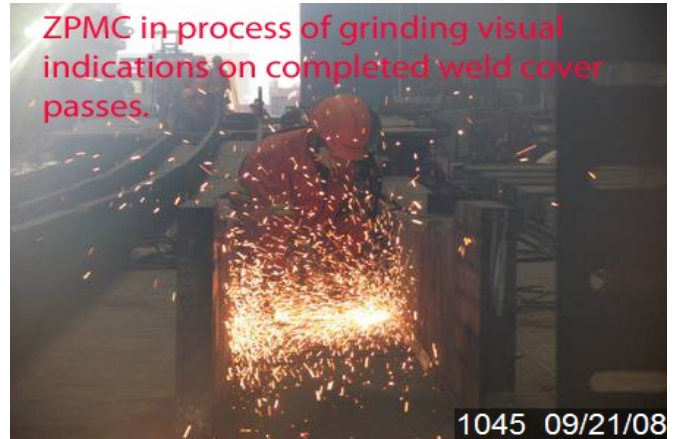
The Quality Assurance Inspector observed ZPMC grinding and performing flux core arc welding (FCAW) on visual weld repairs on Orthotropic Box Girders (OBG) DP-591-001 and DP-164-001.

The Quality Assurance Inspector performed a random final visual observation on Orthotropic Box Girder (OBG) DP-164-001. The items observed by the Quality Assurance Inspector appear to meet contract requirements.
